**TRANSPORTATION SCIENCES CENTER  
ACCIDENT RESEARCH GROUP**

**CALSPAN CASE NO. CA94-31**

**VEHICLE #1 - 1992 TOYOTA CAMRY LE  
DRIVER SIDE AIR BAG  
DRIVER FATALITY**

**ON-SITE INVESTIGATION**

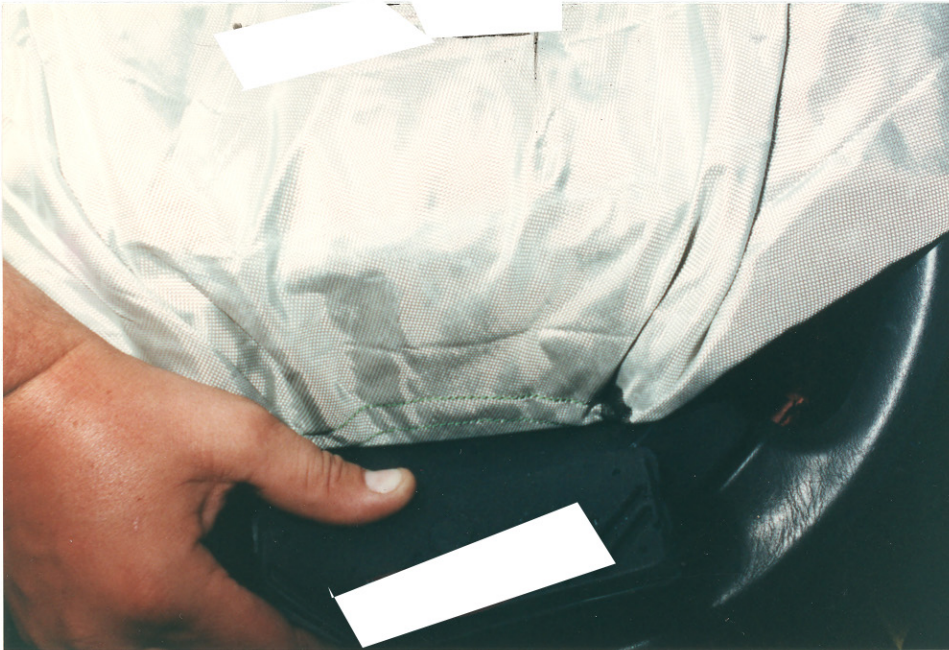
51. View of the inside surface of the lower air bag module cover flap showing a blue identification number applied during assembly ("0821-2").

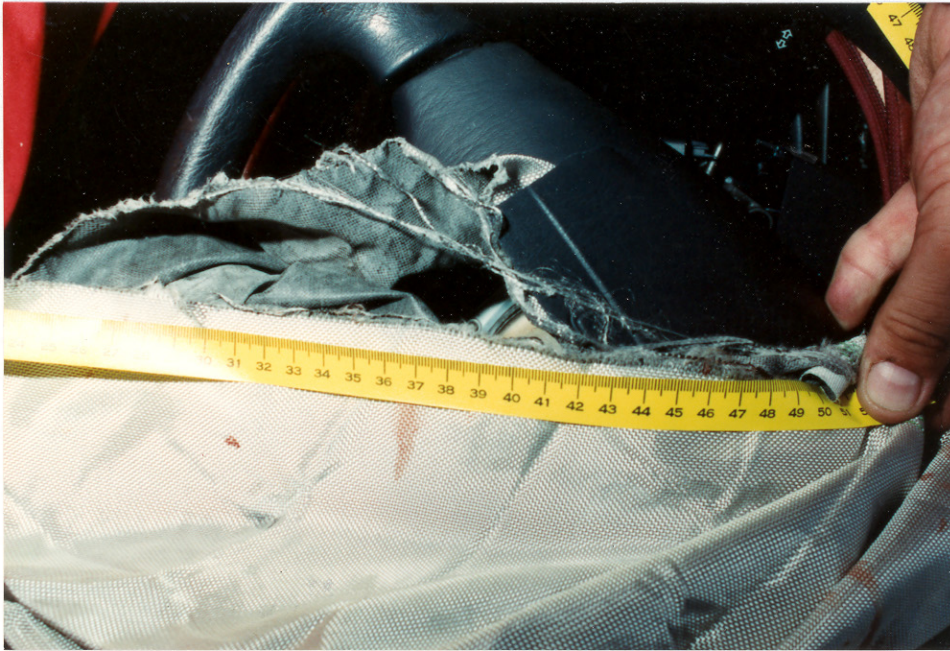
53. View of the air bag tear as it is elongated to show the 35.6 cm (14.0") tear length.

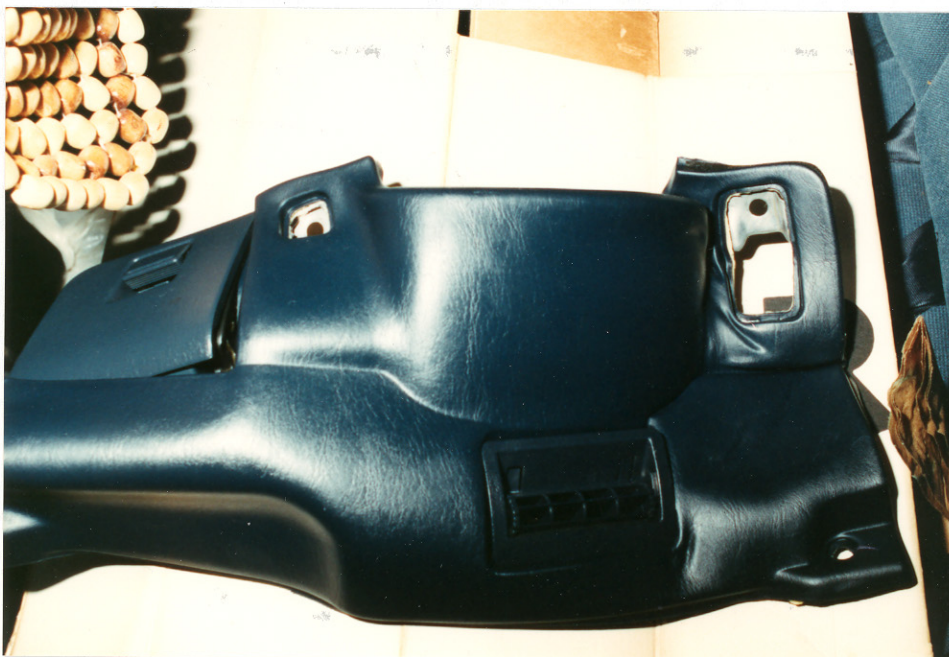
55. View of the knee bolster after removal from the lower instrument panel.

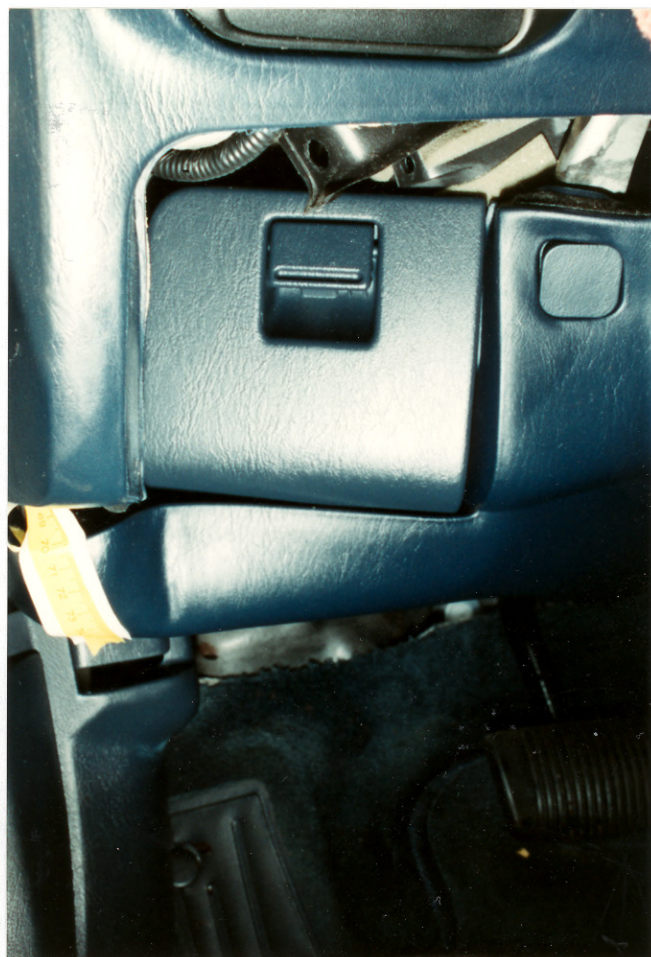
56. View of the left side of the lower instrument panel illustrating contact damage to the fuse panel cover and knee bolster by the driver's left leg.

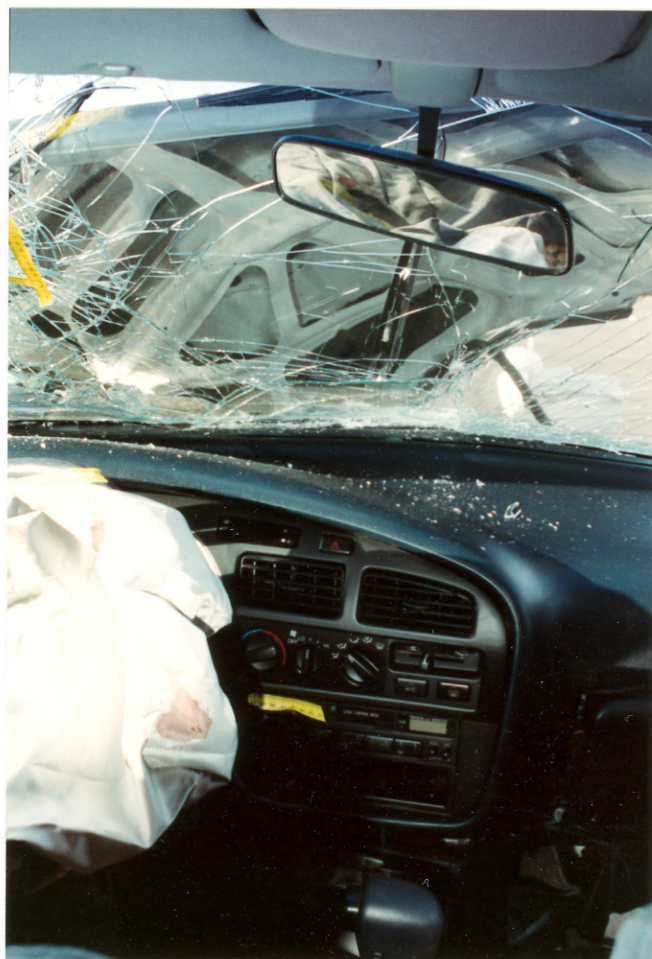
58. View of the center instrument panel and windshield.

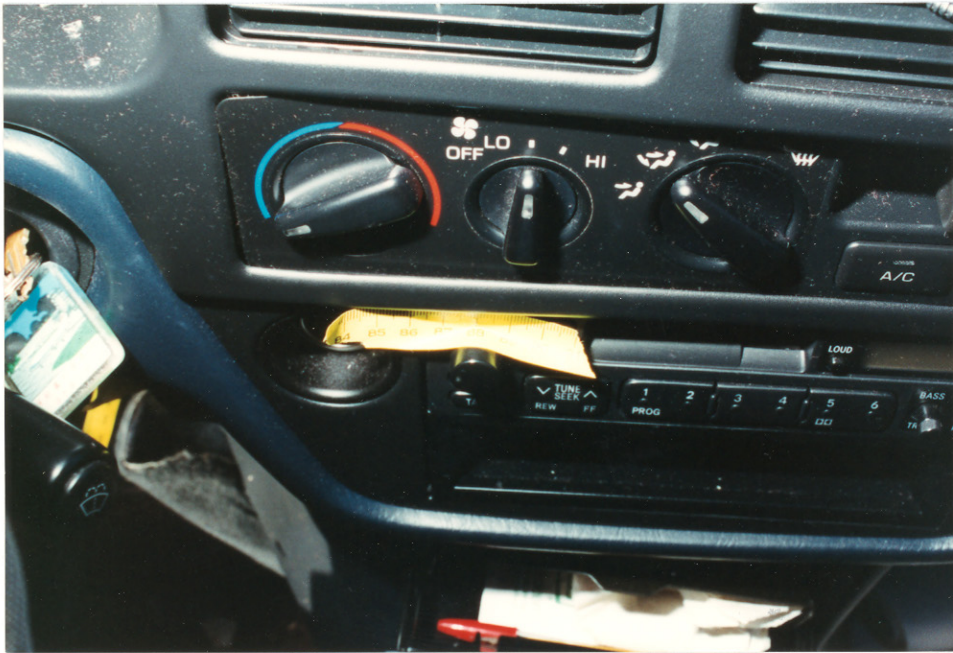
59. Close-up view of contact damage along the mid instrument panel.

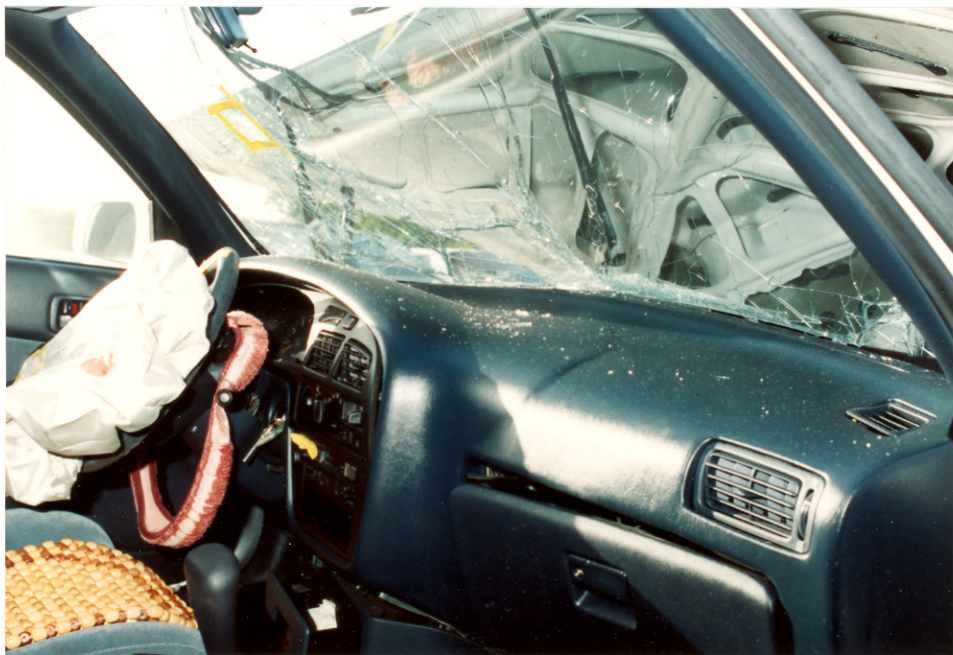
60. Angular view of the instrument panel taken from the right side of the vehicle.

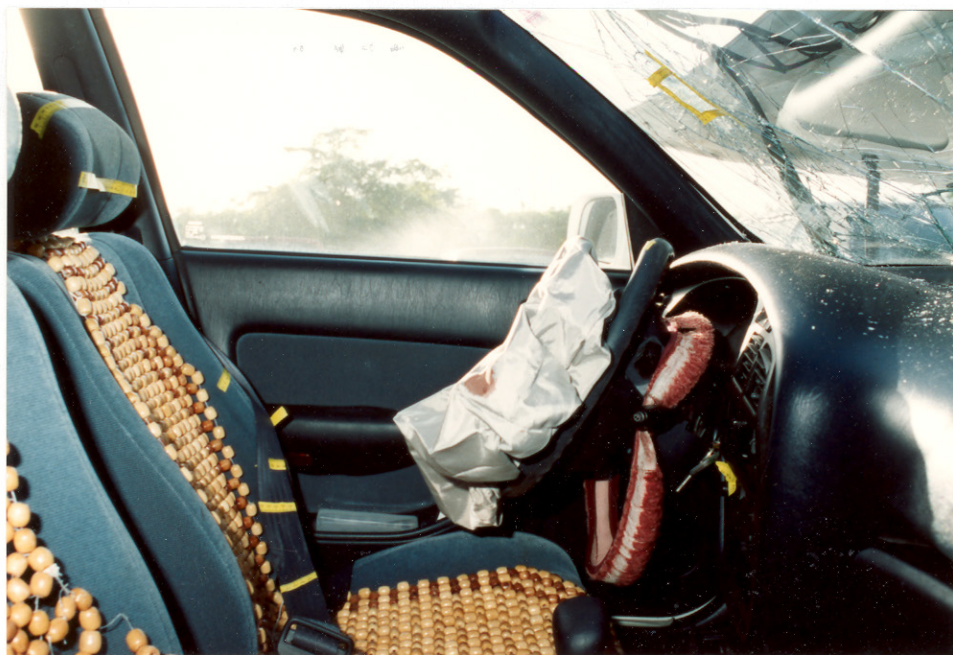
61. Lateral view of the driver's seating area with emphasis on the relative position of the driver's seat with the steering wheel at the time of air bag deployment.

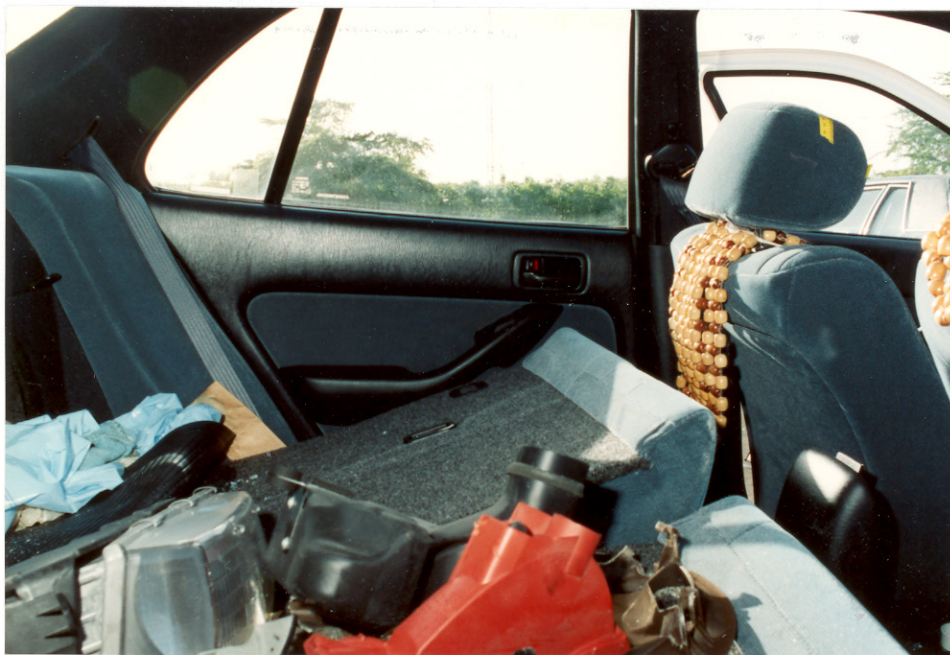
63. Lateral view of the rear seat area taken from the right side.

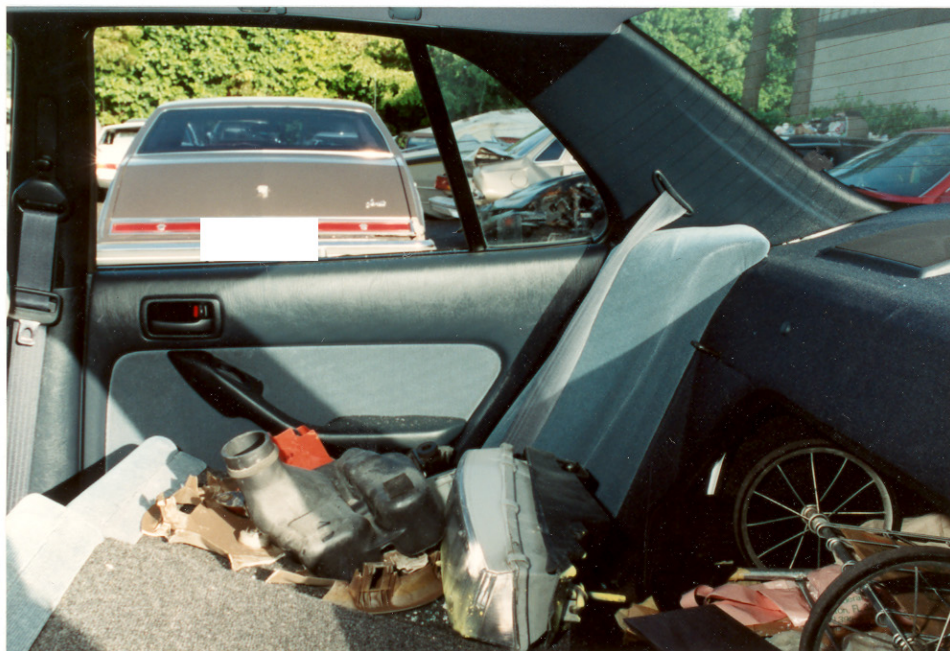
64. Lateral view of the rear seat area taken from the left side.

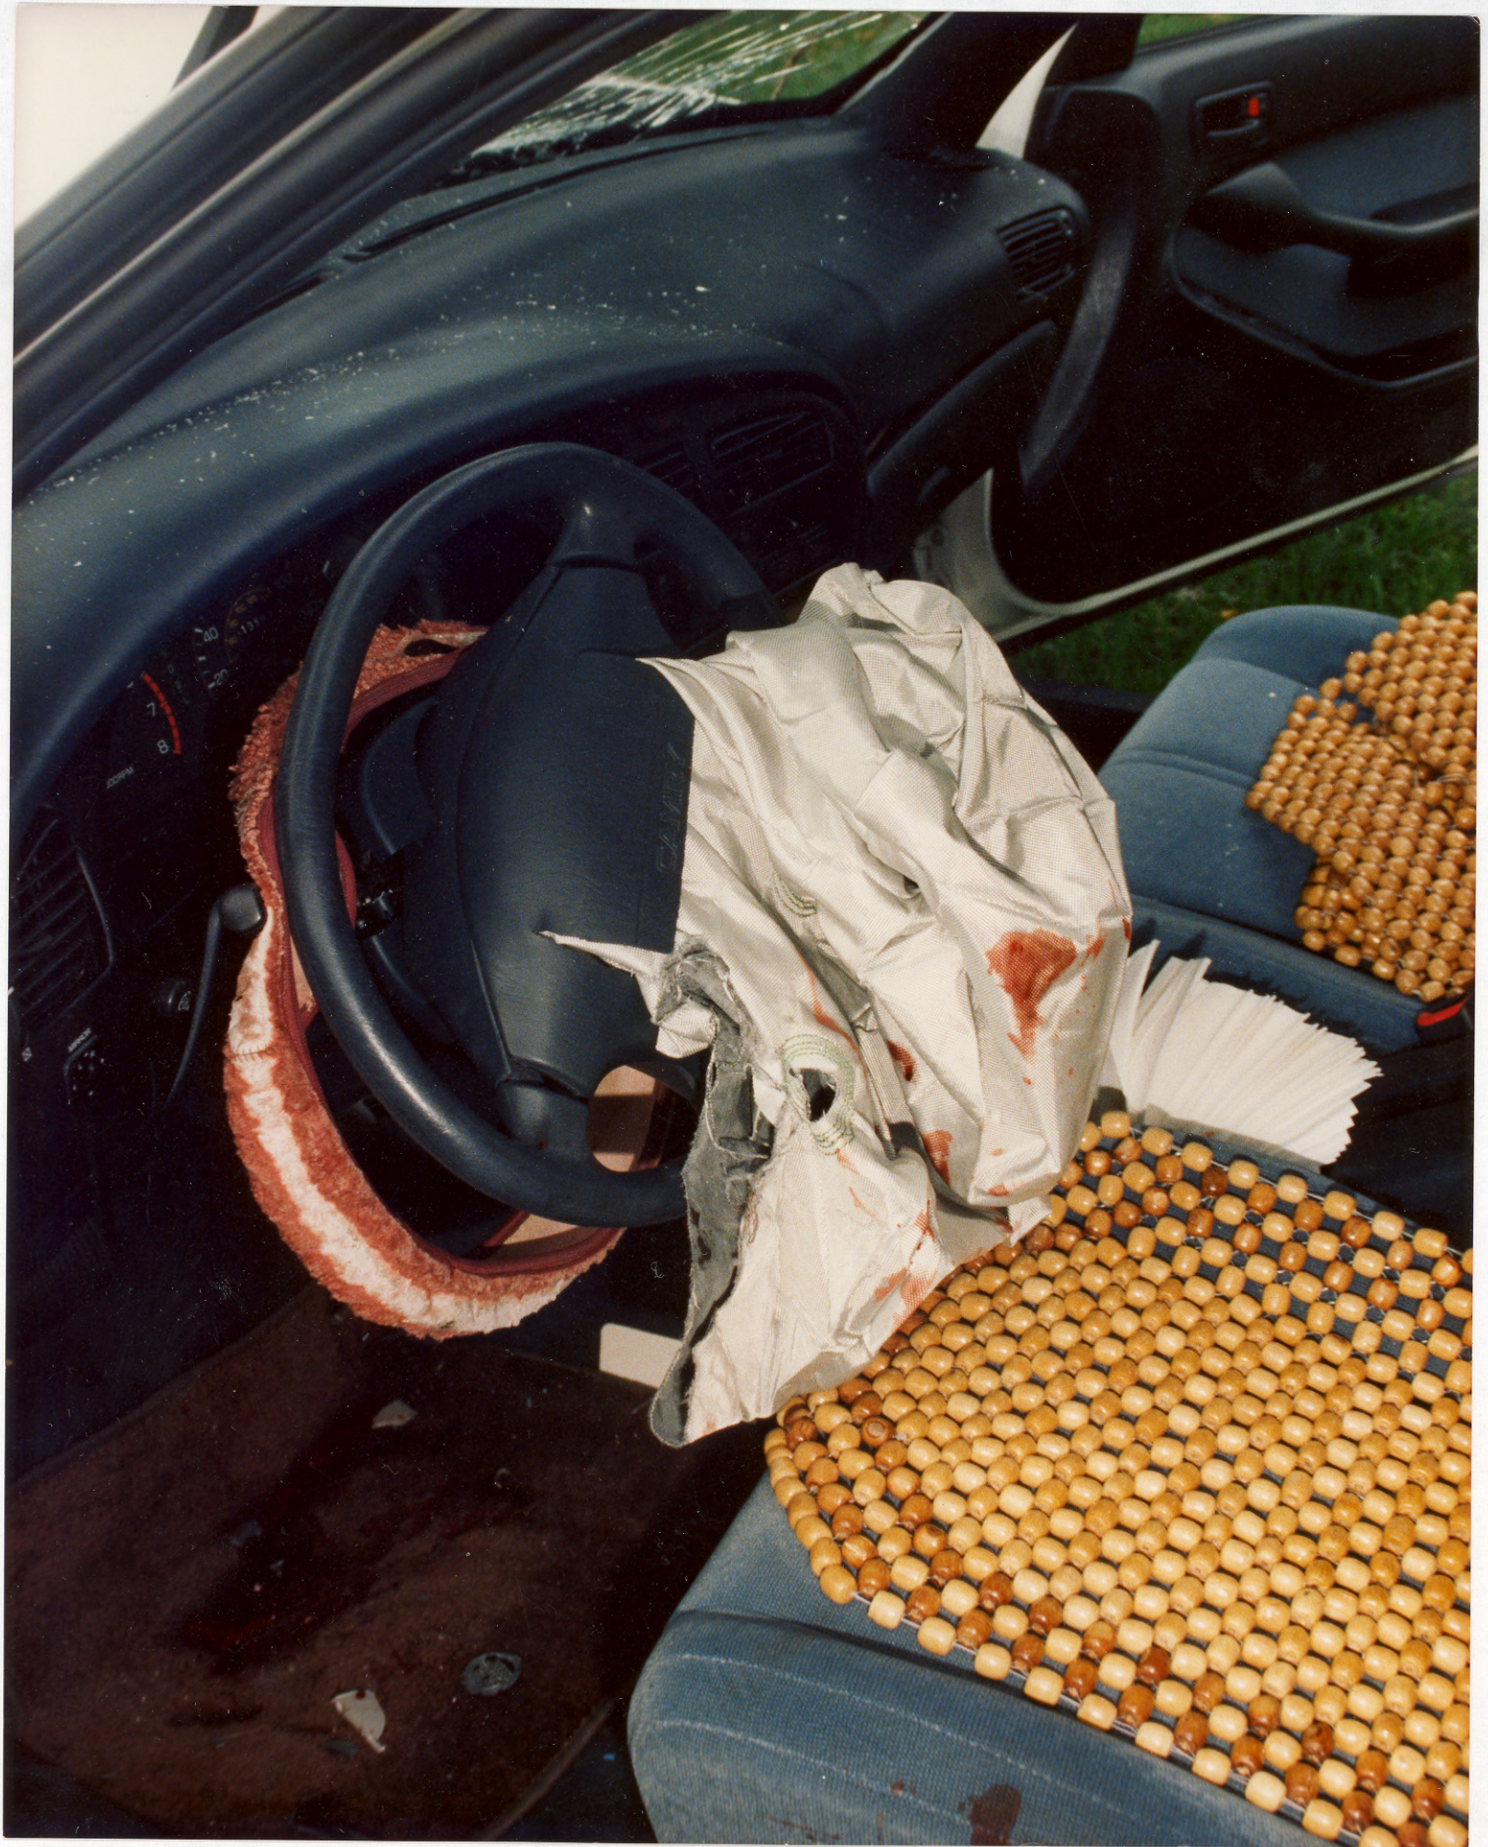
69. On-scene view of the driver side air bag.
